Piper Alpha Oil Rig Explosion

Cole M. Helmer

Widener University · 2024

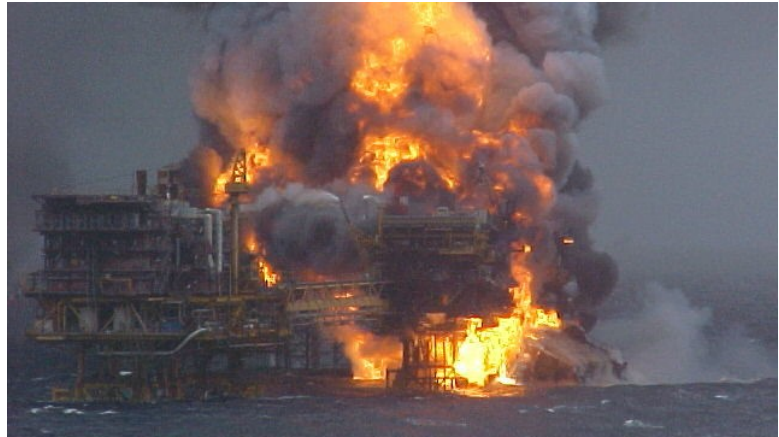
Figure 2. Image from safety4sea, which shows the Oil Rig after the explosions, while on fire.

morning of July 7th majority of the Piper Alpha Oil Rig, lay at the bottom of the sea floor. The fires from the different explosions and oil/gas burning created flames that rose to be over 200 meters tall, along with a peak rate of energy consumption of 100 gigawatts, which is three times the legal amount in UK total energy consumption. After three weeks, the entirety of the fires had yet to be fully extinguished.

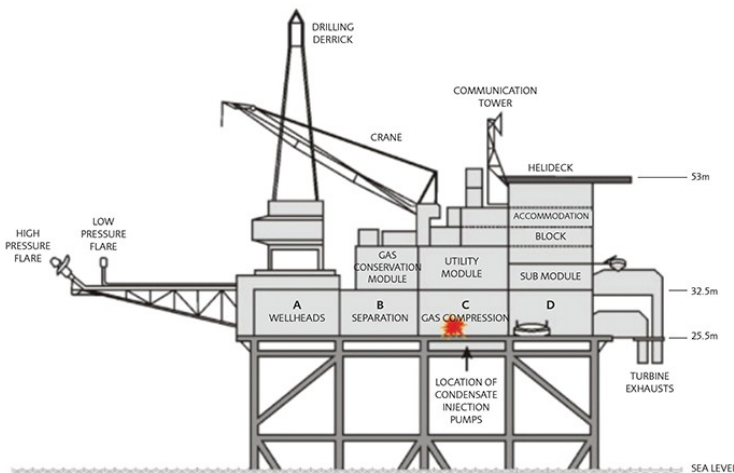
Figure 3. Above is an image from The Chemical Engineer which shows the different sections/modules of the Piper Alpha Rig. This image is a great tool to help follow the events that ultimately led to this catastrophic event.
