# Fukushima Daiichi Nuclear Disaster

Cole M. Helmer

*Widener University · 2024*

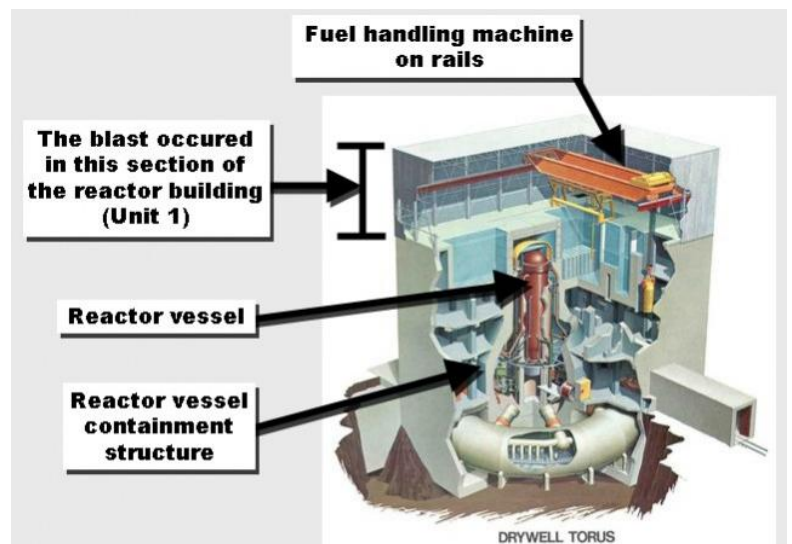
Figure 2. The above image shows where exactly the explosion happened in reactor room one.[1]

The ground began to rumble at Fukushima, everybody unsure of what exactly it was at first. Engineers within the control center began to believe that the core of reactor one exploded, resulting in scattering radioactive fuel over the planet.[5] An engineer present for TEPCO stated that many within the control room started thinking of running to escape, yet running would only put you at an increased risk of radiation poisoning.[5] After about an hour, radiation levels stabilized and it was found out that leaking hydrogen had exploded in the roof of the reactor building(Figure 2), thankfully the core itself was still intact.[5]

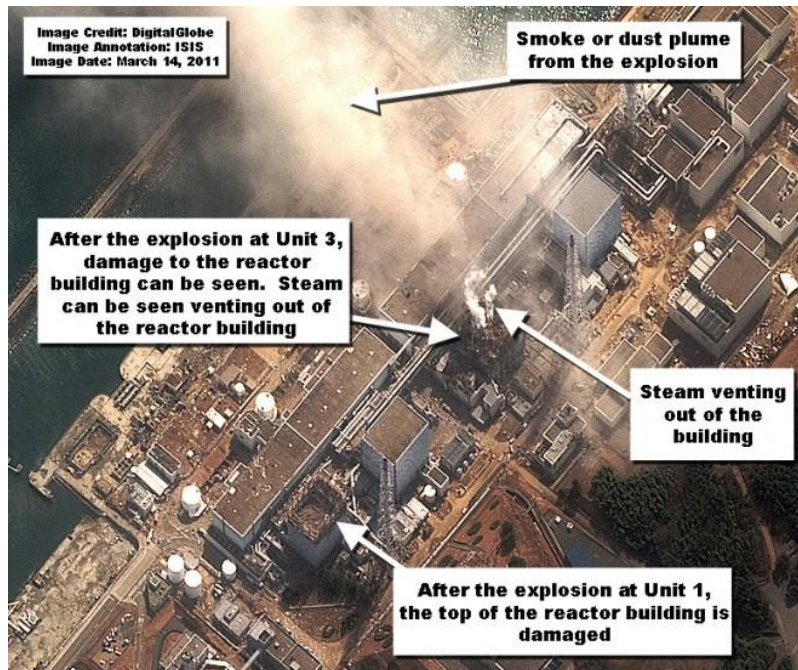
**Figure 3. The above image lays out Fukushima from an aerial view. Labeled are reactor rooms 1 & 3 with room 2 being the one in between still intact.[1]**
