Piper Alpha Oil Rig Explosion

Cole M. Helmer

Widener University · 2024

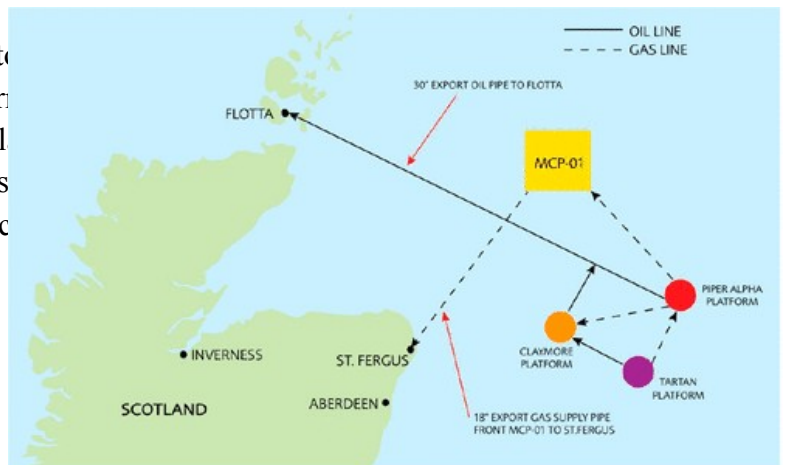
Figure 1. Above is an image that shows the full layout of the Piper Alpha Oil Rig and its corresponding platforms, along with MCP-01.
